# **Human Resources Building**

## **Condition survey**

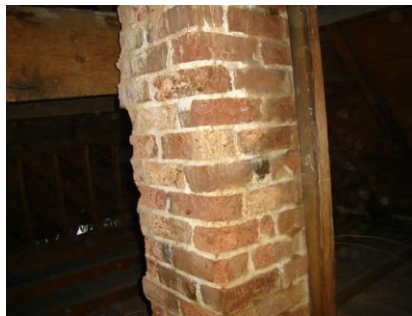
Roof framing

The second floor was built in the same manner as the first with an exception of the flooring material which is carpet rather than laminate. The second floor was originally a host to a pair of masonry chimneys both of which were removed. With only a reminisce of two 8' tall chimneys still remaining in attic. *For safety reasons remainder of chimneys should be removed and disposed of.*

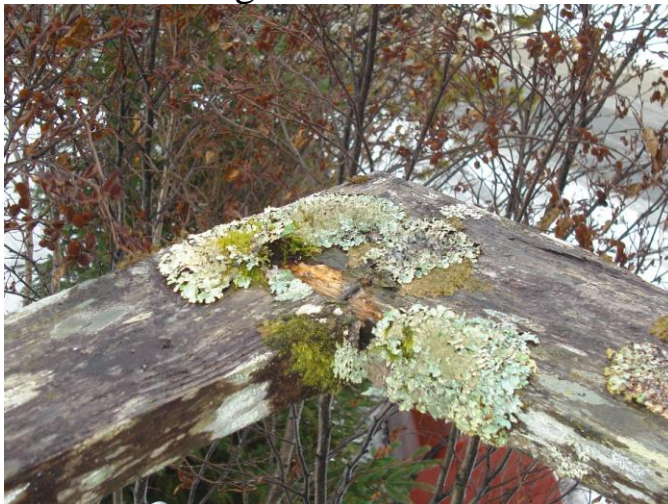
There is an exterior landing on the second floor, on north end of building constructed from standard non-treated, material. Landing and stairs were in very poor condition . Repairs were made see picture below.

Rotted landing and stairs and hand railing.

New stairs .
